BULGARIAN FIGHTER COLOURS 1919–1948

Vol. 1

Rainbow No 9136

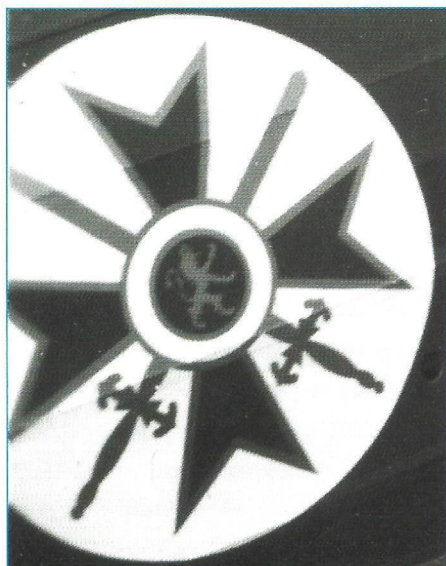
23A. The formal (re)birth of the Văzdushni na Negovo Velichestvo Voyski (VNVV, or His Majesty's Air Army) happened on 27 June 1937.

Prior to this official event, a new military marking had been designed and applied to all newly-delivered German combat aircraft. This new military marking, depicted on the fuselage of an Arado Ar 65F fighter, was based on the Bulgarian royal coat of arms and resembled closely the Bulgarian Order of Bravery, 4th Class.

was superimposed over a large diameter white circle⁶. [photo 23A] The diameter of the marking, based on calculations done by the Author using various photos with valid reference dimensions (e.g. tyre size), varied between 900 mm, 800 mm, or 600 mm, depending of the aircraft type and the location on the airframe it was applied to. For example, on the PZL P.24s, the largest size roundel (around 900 mm) was applied on the wings, while on the fuselage the smallest size (around 600 mm) was used. The 'tsarist roundel' type military marking – unofficially referred to as знак “кръст за храброст”, or 'Bravery Cross' Sign – was applied in six positions: on either fuselage sides and on the upper and lower surfaces of the wing(s). [photo 24] The rudder continued to be painted in three identically wide horizontal stripes in Bulgaria's national colours – white, green and red (from top to bottom).

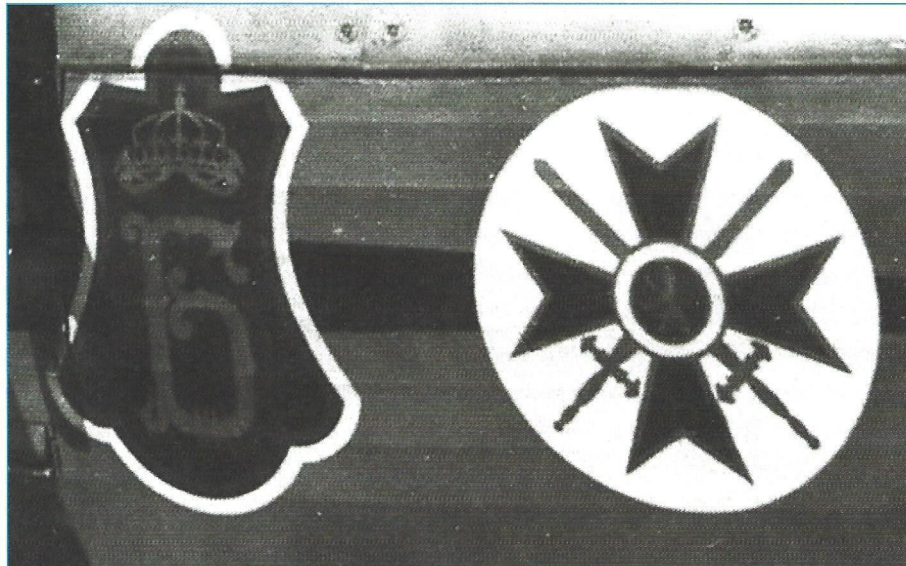
23B. The new, so-called 'Tsarist Roundel' type marking (at right), along with the Royal Cipher of Tsar Boris III (at left), as worn on the side of an Arado Ar 65F.

On two early German aircraft types – the Arado Ar 65 fighter and the Dornier Do 11 bomber – an elaborate 'Royal Cipher' was also applied on the airframe. This emblem symbolised the generosity of Tsar Boris III, who reportedly paid for these aircraft with his own money and donated them to the air force⁷. This 'Royal Cipher' of about 1000 mm height and 600 mm width consisted of a yellow (or golden) Cyrillic letter 'B' (B for Boris) with the identically coloured royal crown over it, superimposed over a red (crimson) shield, which was outlined with thick green and white borders – symbolising Bulgaria's national colours. [photo 23B]

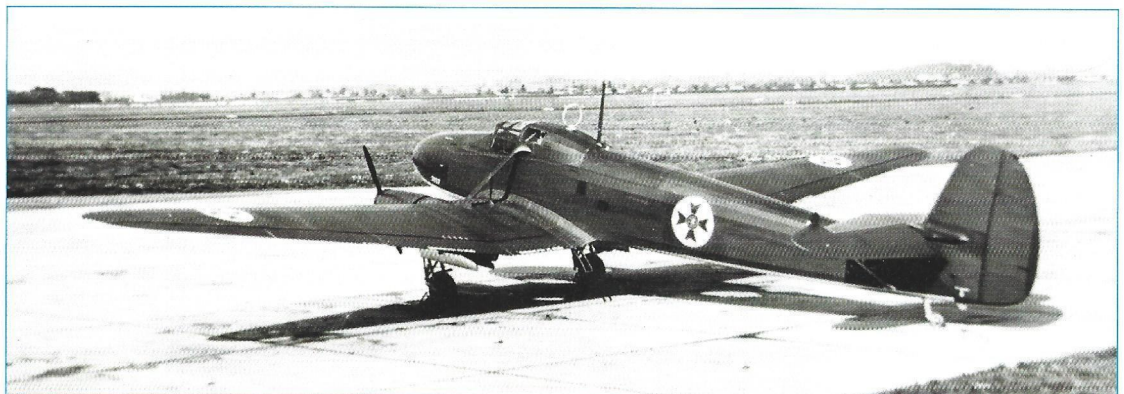
24. The 'Tsarist Roundel' type of military marking was applied in six positions: on both sides of the fuselage, as well as on the upper and lower surfaces of the wing, as depicted on this freshly delivered Focke-Wulf Fw 58KB-1. The Bulgarian national colours are yet to be applied on the rudder.

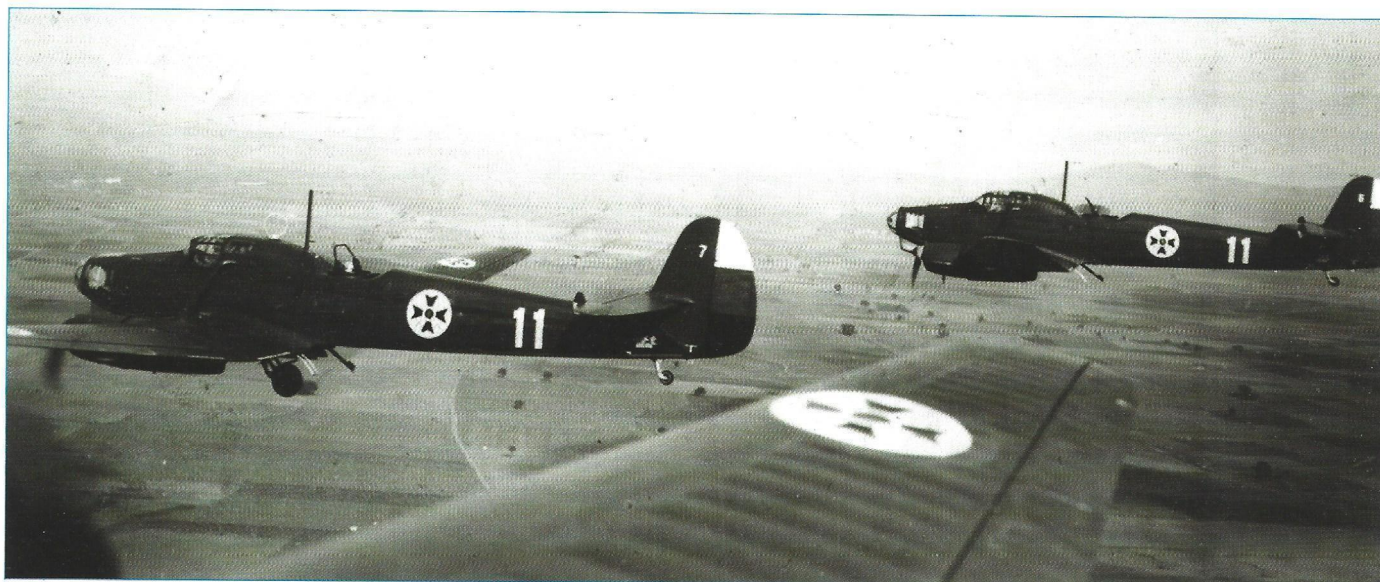
26. With the introduction of military markings, a numbering system was also established to identify individual aircraft of the VNVV. It consisted of two groups of numbers, one applied on the fin, the other one on the rear fuselage, as shown on the Fw 58KB-1 krilo of the 5. Bombardirovachen Orlyak (Bomber Group). The meaning of this numbering system is not fully understood; however, a theory drawn up by the Author can be read in the main text of this chapter.

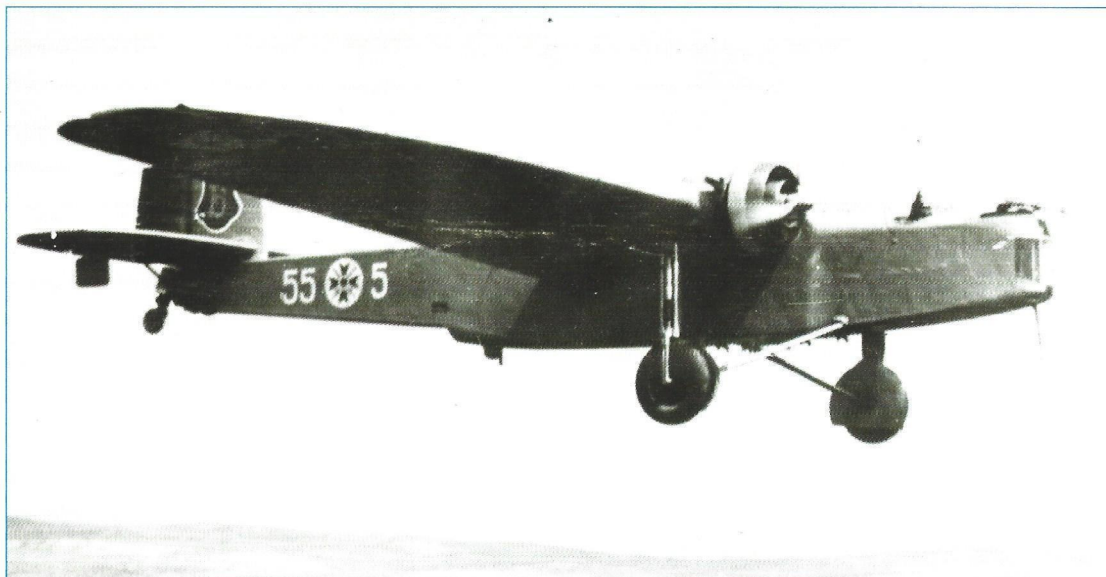
27. The dozen Dornier Do 11 bombers of the 5th Bomber Group wore numbers from 55-1 to 55-12 applied on the fuselage, on either side of the military marking (as the fin was already covered by the so-called "royal cipher").

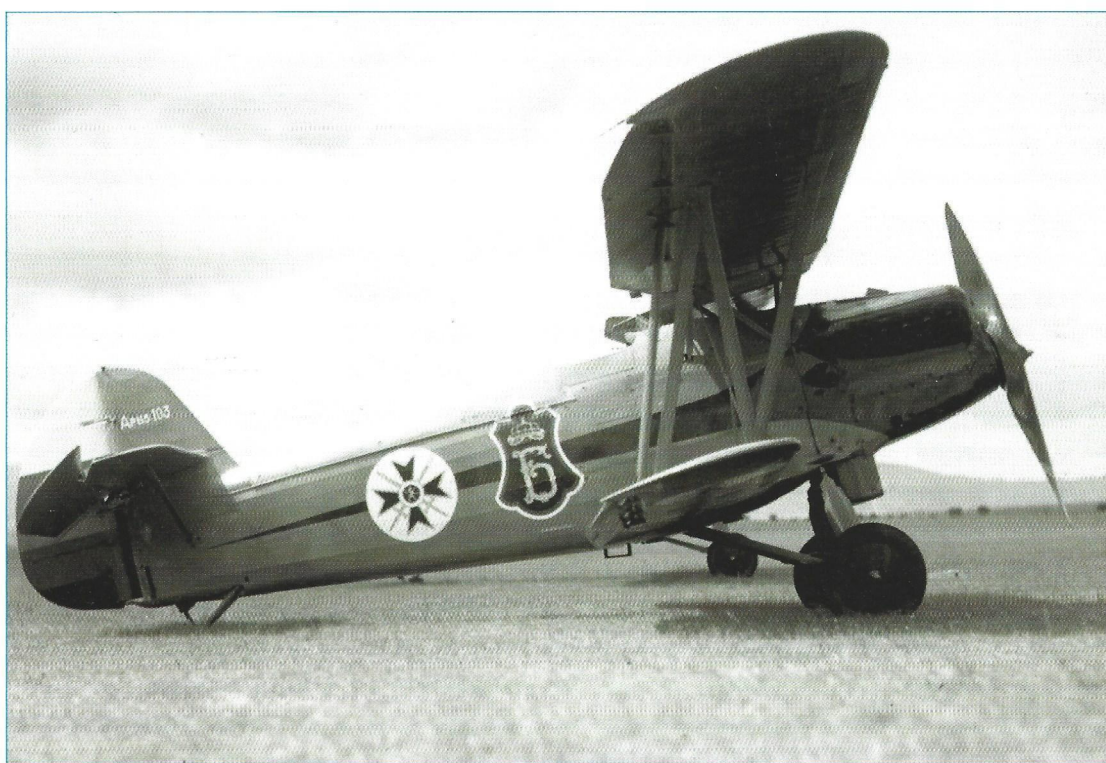
28. The dozen Arado Ar 65 fighters that entered service in early 1937 – thus after the first wave of warplanes had arrived from Germany – were identified by a small white text on the fin top, which included the aircraft type, in Cyrillic (i.e., 'Ap.65'), followed by a serial number starting with 101, linked to the aircraft type with a dash

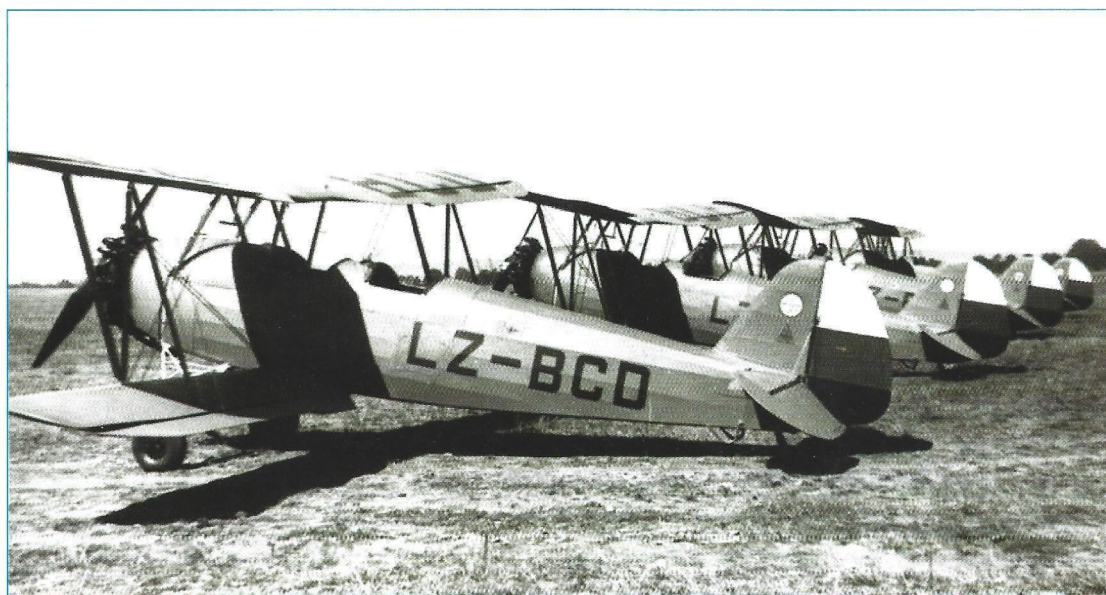
28A. Based on the order issued on 14 April 1938, all trainers must be painted completely yellow. Certainly, imported aircraft wore their original factory livery, which was usually light grey. However, Bulgarian-made trainers may have been painted yellow at the factory, as per local standards. It's extremely hard to differentiate yellow from light grey on period black/white photos: However, the Author believes this line-up of DAR-9 trainers, freshly rolled off the assembly line (and paint shop) of DSF Plant in Lovech, may have indeed been painted yellow overall. LZ-BCD was the 10th DAR-9 (2/1 series), NN 10/7051.

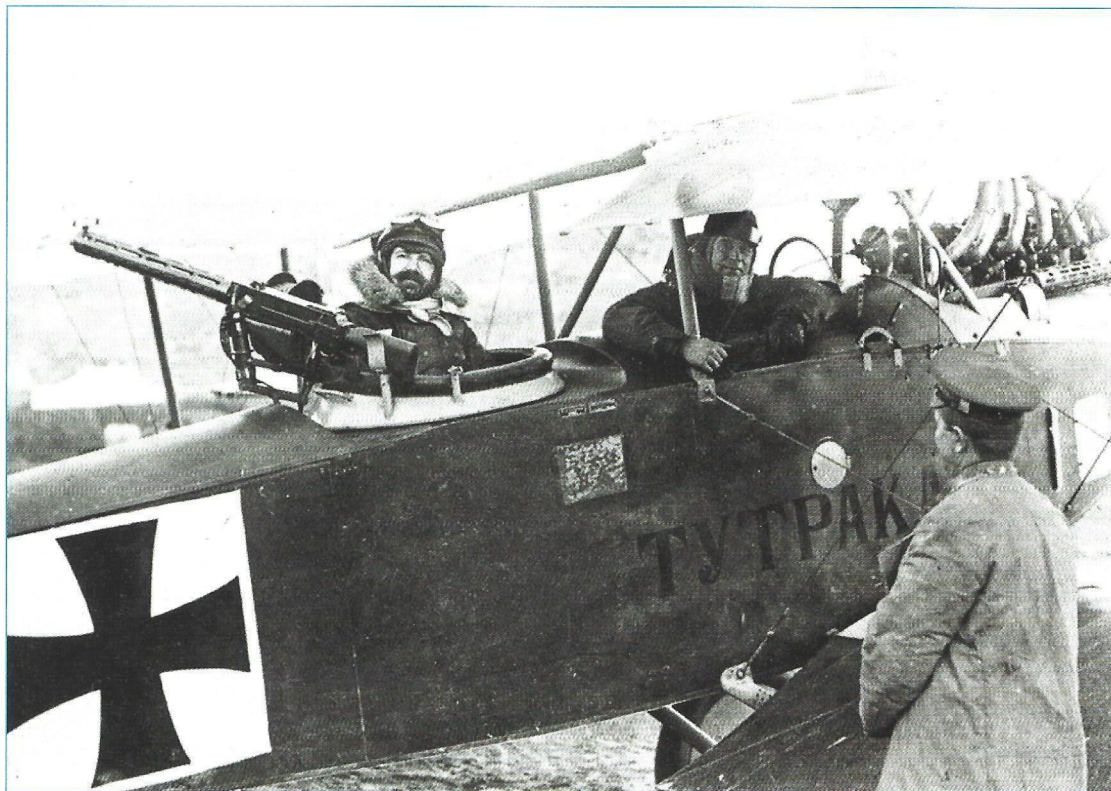
29A. During World War 1, Bulgarian-manned warplanes occasionally bore specific names, distinguishing them from their German ally wearing the same military marking. In this particular case, the name written in Cyrillic letters, ТУТРАКАН (TUTRAKAN), painted on the fuselage of an Albatros C.III, refers to a Bulgarian city located in north-east Bulgaria, on the right bank of the River Danube. After the short Second Balkan War of 1913, it was incorporated, along with all of Southern Dobrudzha (also known as Quadrilateral), in the Kingdom of Rumania. During World War 1, the town was the location of the important 'Battle of Tutrakan (Turtucaia, in Rumanian)', during which Bulgarian and German Central Powers forces defeated the Rumanian forces. At rear, in the observer's location, Lieutenant Colonel Vasil Zlatarov, commanding officer of the Bulgarian Aviation during World War 1, is seated.

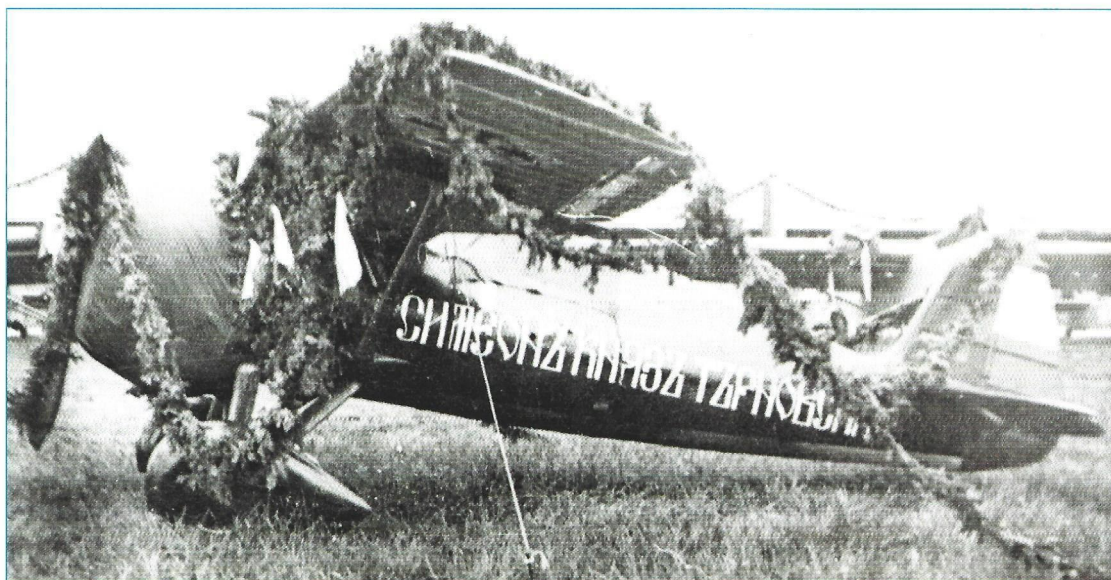
29B. Occasionally, Bulgarian military aircraft were applied with special writings, in honour of a certain person or event. This practice was used from the WW 1-era. The depicted PZL P.24 fighter aircraft bore white Cyrillic text on both sides of the fuselage, which spelled: Симеонъ Князь Търновски ("Simeon Knyaz Tarnovski"), referring to the new-born son of the Tsar, Crown Prince Simeon Tarnovski (born on 16 June 1937).

Occasionally, Bulgarian military aircraft were applied with special markings, in honour of a certain person or event. During WW 1, Bulgarian-manned warplanes occasionally bore specific names, distinguishing them from their German ally wearing the same military marking. [photos 29A and 38] A couple of Heinkel He 51 fighter aircraft sported a large text applied in black capital letters on their lower wing undersurface in mid-1937. One of these spelled: СИМЕОНЪ, or Simeon – the name of Tsar Boris' new-born son – while the other carried миньоръ, or Miner, in honour of the coal miners of the town of Pernik, who reportedly paid for that particular aircraft. A PZL P.24 fighter aircraft bore a white Cyrillic text on both sides of the fuselage, which spelled: *Симеонъ Князь Търновски* ("Simeon Knyaz Tarnovski"), also referring to the new-born son of the Tsar, Crown Prince Simeon Tarnovski (born on 16 June 1937). [photo 29B]

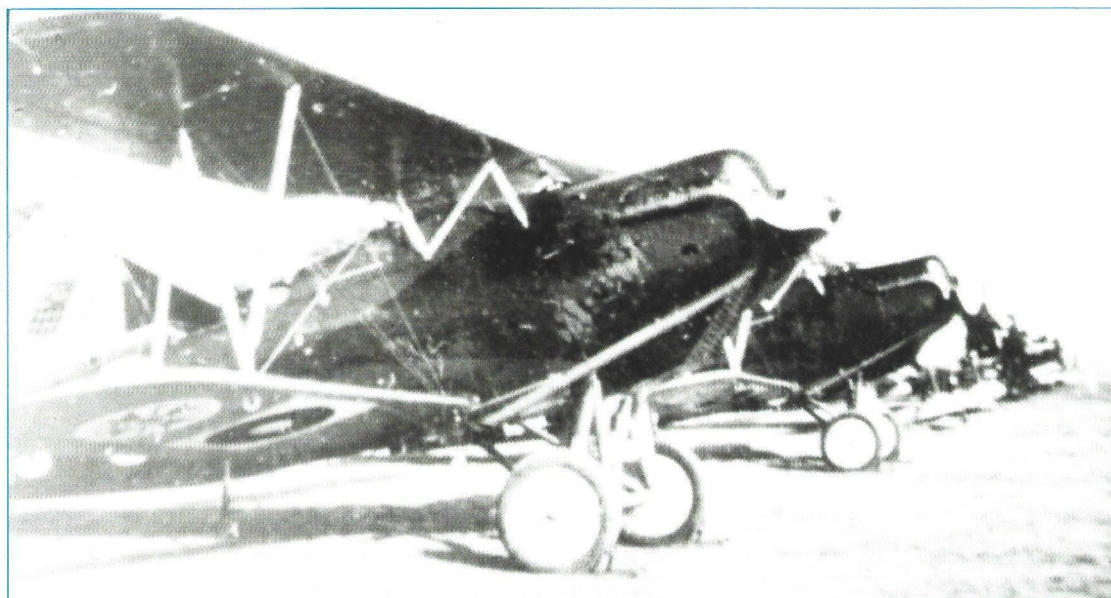
30. A few Bulgarian warplanes wore, for a short while, alongside the regular military marking also roundels on their underwing surfaces (it is unlikely that they were applied on the upper wing as well), superimposed over a white square background. One description mentions this symbol as black circle, with white dot in centre, applied over a white square. These markings were probably used only during wargames, and were of temporary use only. One such rare occurrence is documented by the enclosed indifferent quality photo, which depicts a couple of Heinkel He 45s, lined up for inspection.

A few Bulgarian aircraft types (most notable the Heinkel He 45, but proof exists where it can be seen on at least one He 72, No. 2), which wore the new military marking, also displayed for a short while a new version of the roundel on their underwing surfaces (and possibly on the upper one, too). The roundel appears to have consisted of rings of red-green-white (inside dot) colour, superimposed over a white square background. This marking was probably used during wargames, and was of temporary and limited use only. [photo 30]. Interestingly, a photo published in a periodical, depicting a couple of Dornier Do 11 bombers in flight, shows a different roundel painted over a white square on the wing undersurface. This time, the roundel did not have a white dot in the centre, meaning that these temporary identification markings, used during wargames, were not identical.

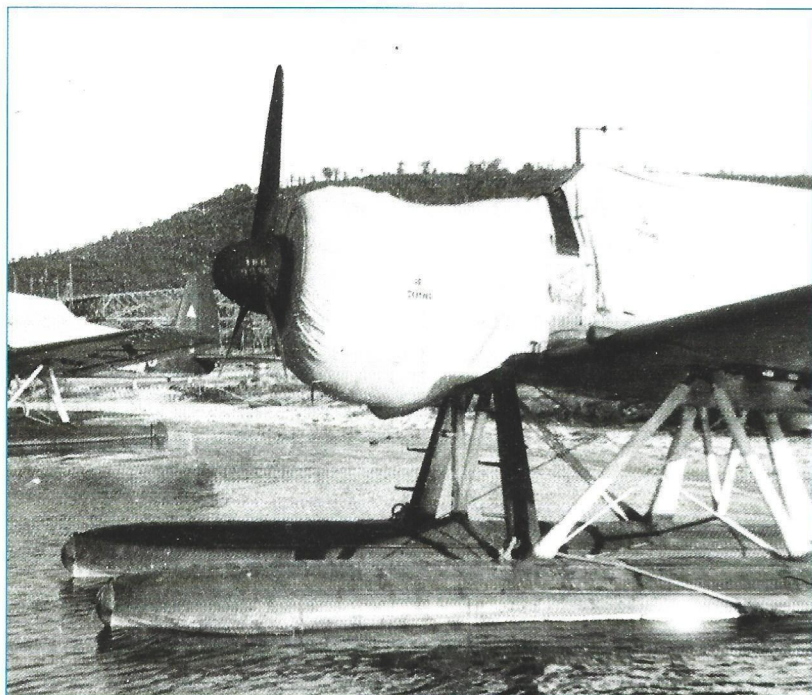
31. In April 1938, a universal coding system, called nomenklaturen nomer (NN, registration number), was introduced to identify all Bulgarian aircraft – wearing military or civilian registration (however, this system was implemented on aircraft only a year later). In writing form, the individual aircraft number, placed first, was separated by the category number, identifying a particular aircraft type, which together gave the aircraft's individual nomenklaturen nomer. On this photo, the NN 3/7096, written on the protecting canvas, identifies the third Arado Ar 196 floatplane in VNVV service. This particular aircraft is currently displayed at the Aviation museum in Krumovo, near Plovdiv. It was recently restored in wartime livery, complete with St. Andrew's Cross-type military marking, as the only aircraft type used by the Bulgarian air force during the war and afterwards.

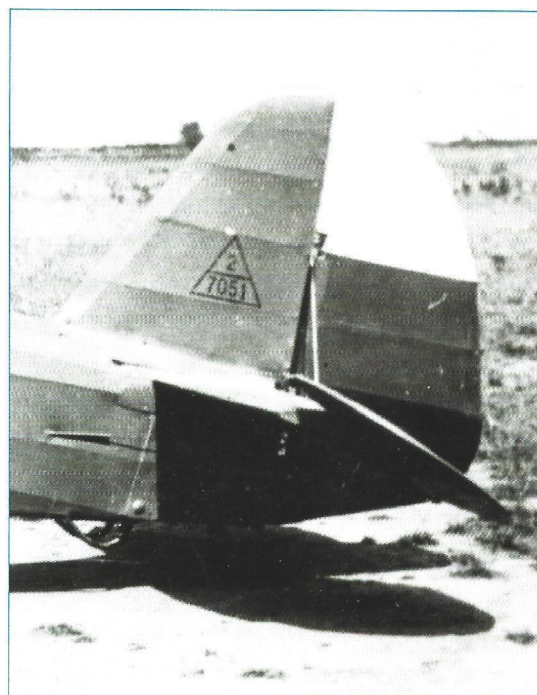
32. On aircraft, the nomenklaturen nomer (NN) was applied within an equilateral triangle, which was divided in two by a horizontal line. The two sets of numbers (detailed in the previous photo caption) were written in the two separated areas of the triangle, as a fraction, as follows: the aircraft's individual serial number was written in the numerator (at the top), while the four-digit aircraft type category number was written in the denominator (at the bottom). This peculiar Bulgarian triangle is illustrated as applied, in black, on the fin of a domestically built DAR-9 'Siniger' biplane (c/n 89), registered LZ-BPB, NN 2/7051. The trainer may have been painted yellow overall.

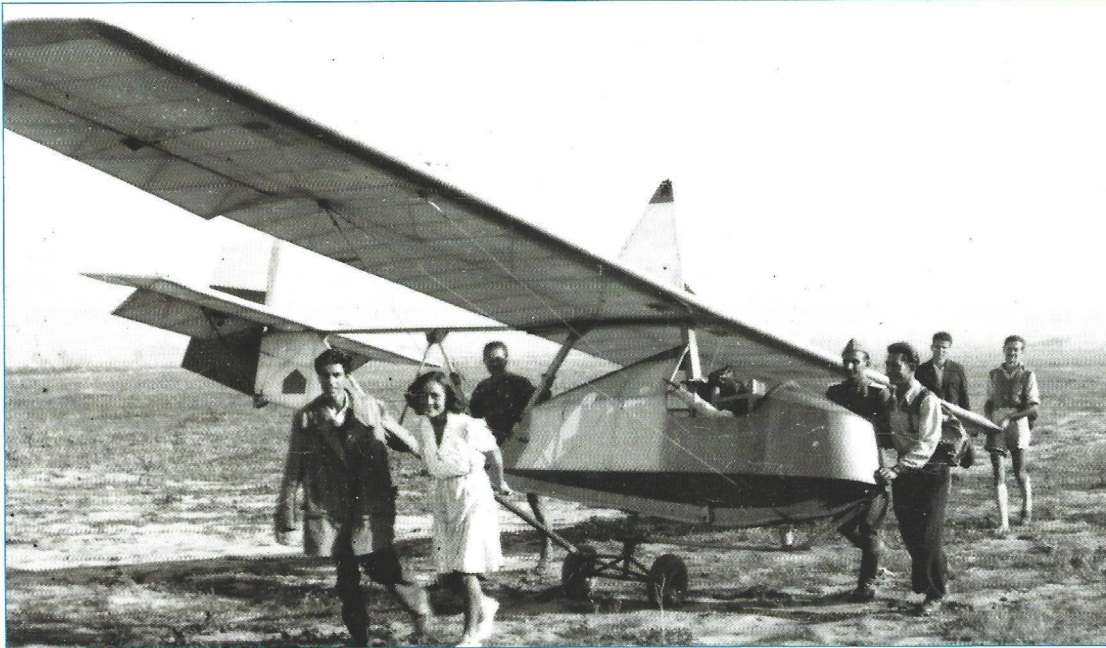
33. It is unclear if the NN was also applied on gliders. This photo shows a UP-1 glider (licence made Grunau 9) being towed by youngsters in the early post-war period. A pentagon-like geometric form can be observed under the horizontal stabiliser (tailplane), to the left of the head of the man at left, consistent with the location of the NN triangle on powered aircraft, without any numbers being visible in it, however.

13 The issue of the usage of the NN on gliders (if it was the case at all) is still not clarified. In official VNVV aircraft write-off documents, where all aircraft are identified by their NN, the few gliders that are mentioned (three Komar and four Zögling, written off on 1 June 1943) are identified by their construction numbers. However, on a rare period photo showing a finless UP-1 glider (licence made Grunau 9) being towed by youngsters in the early post-war period, a pentagon-like form can be observed under the horizontal stabiliser (tailplane), consistent with the location of the NN triangle on powered aircraft, without any numbers being visible in it, however [photo 33].

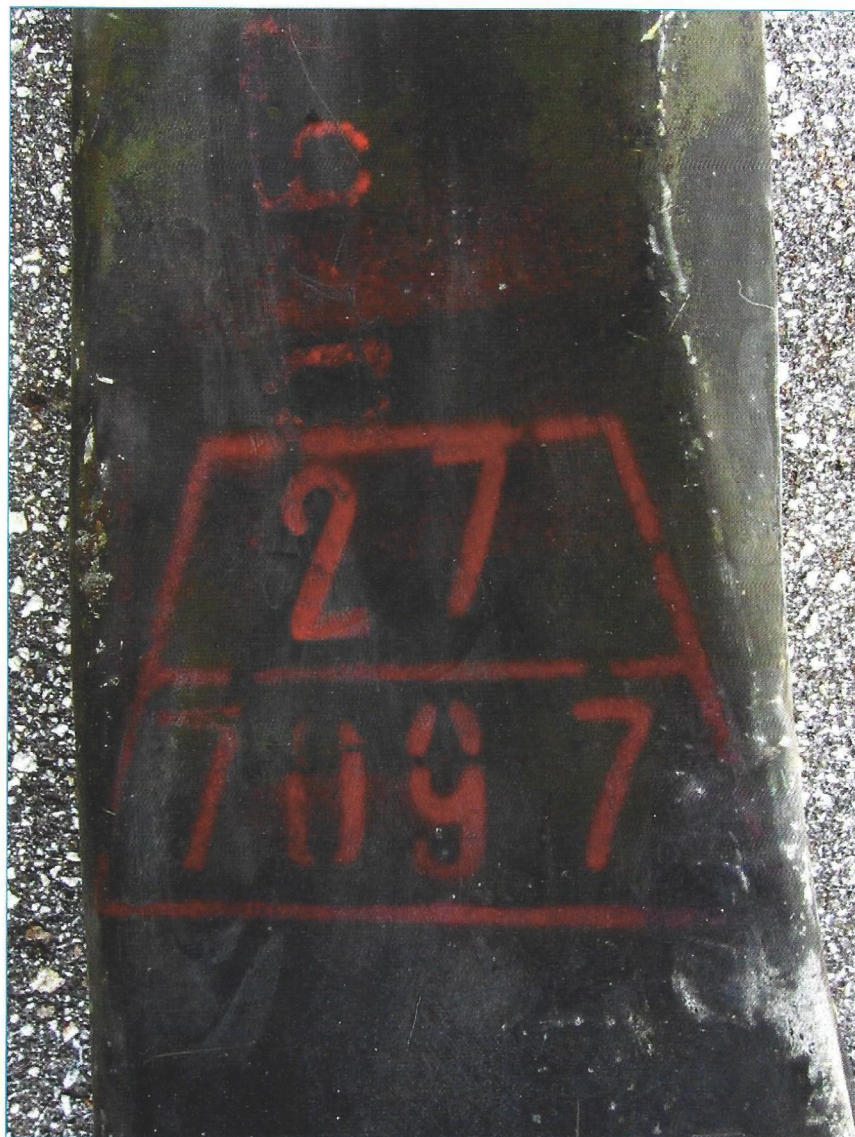
35. The only original aircraft component with the typical triangle on it found by the Author is tubing from a Yak-9P fighter, preserved at the Bulgarian aviation museum at Krumovo (see photos 52A and 52B). Interestingly, the sign is actually an equilateral (isosceles) trapezoid, not a triangle. The aircraft's individual serial number is written in the numerator (at the top), while the four-digit aircraft type category number in the denominator (at the bottom), resulting in the NN 27/7097. What is believed to be the aircraft's construction number, 0267, is also stencilled on the tube, also in red, over the truncated triangle.

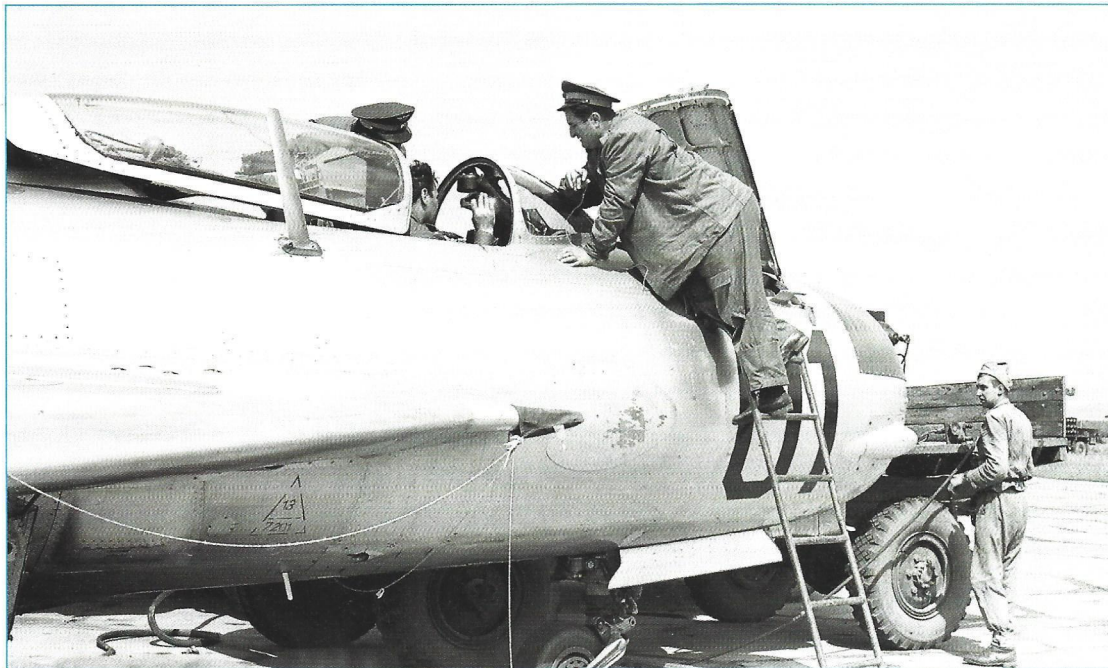
36. The nomenklaturen nomer (NN) was used up until the 1970s, including on MiG jets. This MiG-19P, No. 01 formerly No. 436 (c/n 620436), NN 13/7201 (triangle applied on the mid-fuselage, underneath the wing), is shown as sample illustration. The Author believes the entire aircraft type category system was reset sometime in the late 1950s and started anew, with all newly introduced aircraft types being assigned subsequently increasing numbers, regardless of their role, or category. Thus the MiG-19P, clearly a fighter type, was assigned with the aircraft type number 7201, which originally meant a basic trainer.

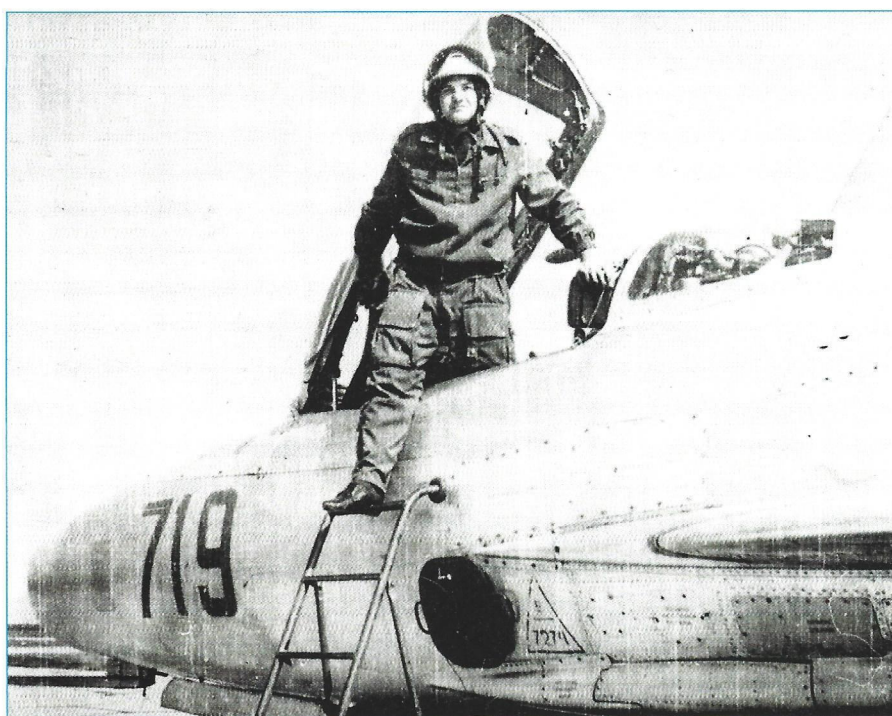
37. Photographic proof of the usage of the NN on more advanced jets includes this MiG-21 F13, No. 719, c/n 1019, NN 9/7274 (triangle applied on the mid-fuselage). For general description of the post-war aircraft registration systems, see note under the List of NNs (however, this topic falls out of the immediate scope of the Author's research).

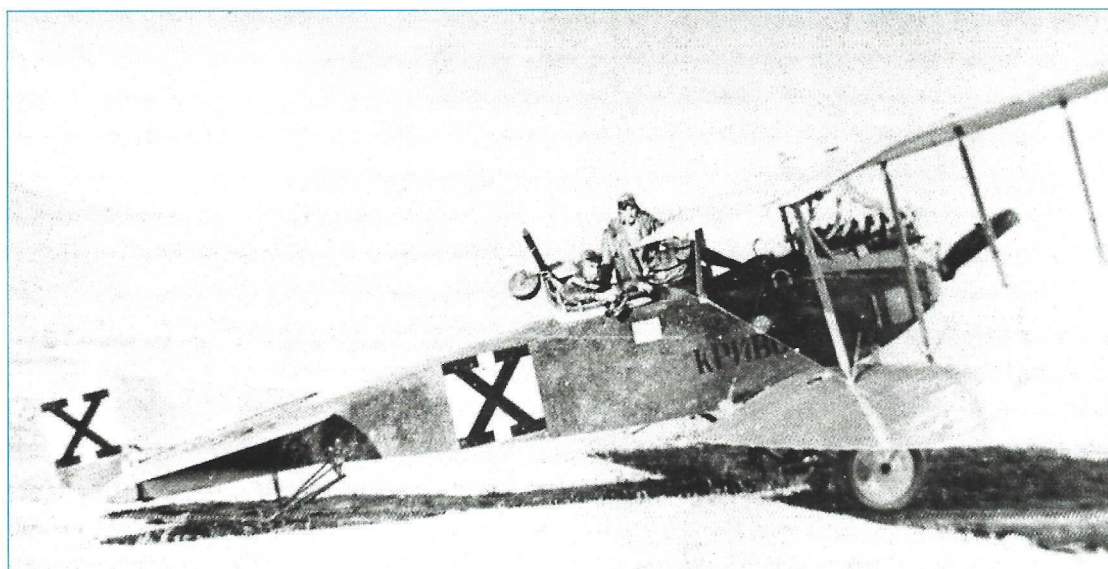
38. At the end of World War I, the military marking resembling St. Andrew's Cross was rarely worn on a variety of aircraft, including at least an Albatros C.III two-seater (depicted), although it was not officially sanctioned. This particular biplane was named КРИВОЛАК (Krivolak) after the victorious battle of Krivolak (Macedonia), against the French, in November 1915.

Details of the initial versions of the proposed new marking are sketchy; the only available information is that three versions, based on the 'St. Andrew's Cross'¹⁷ (i.e. an X shape), were tested on several aircraft of the 1st Orlyak, based at Bozhurishte, in March 1940. The purpose of these tests was to determine which one of the three versions was most visible (Order No. 14 of 1st Orlyak, 18.03.1940). There is no primary information available on the outcome, but it can be assumed that the well-known version applied later on was the winning design. It has to be noted that it was not a novelty for Bulgarian aircraft to wear military marking resembling the 'St. Andrew's Cross', applied in black (not green, as some artwork suggests). At the end of World War I, such a marking was occasionally worn on a variety of aircraft, including at least one Albatros C.III two-seater, although it was not officially sanctioned. [photo 38]

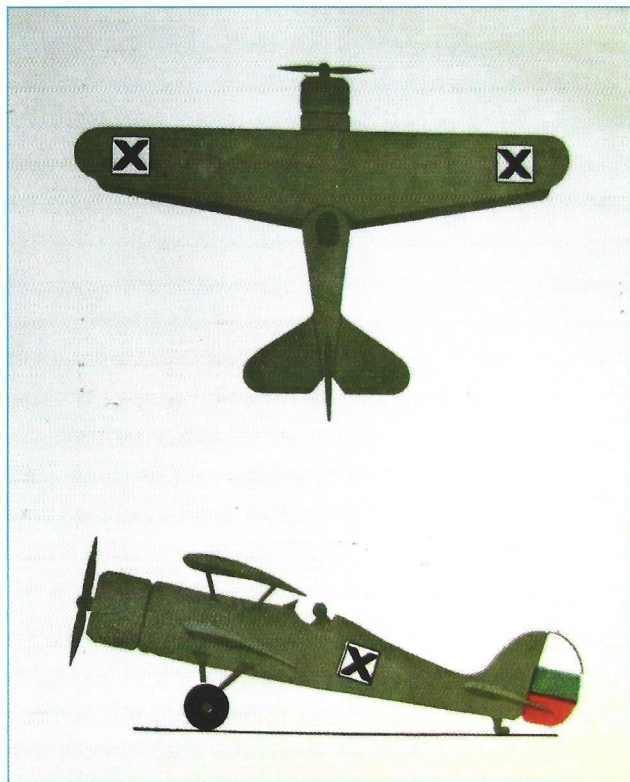
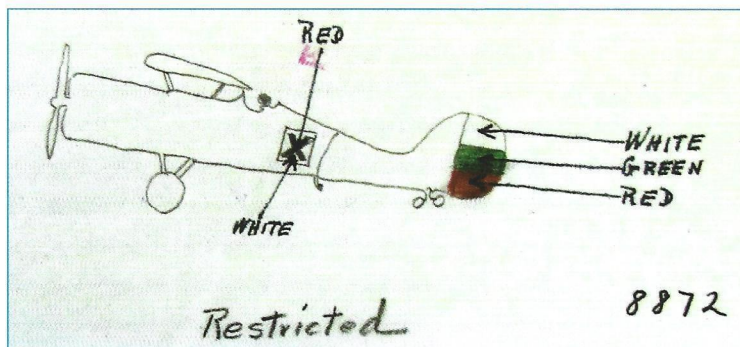
41A. Left: An unlikely source detailing the new Bulgarian military marking are US diplomatic files. A 'note-verbale' issued by the Bulgarian Royal Ministry of Foreign Affairs and Cults in Sofia, on 13 August 1940, informs the US Legation in Sofia of "the new distinctive markings of recognition (sic!) of Bulgarian military airplanes," and encloses the following simple hand-drawn sketch.

41B. Above: Another US diplomatic document mentioning Bulgarian military marking was issued by the US Embassy in Istanbul, Turkey. Report No. 8872 of 3 February 1944 details "the markings on Bulgarian pursuit planes", based on verbal (i.e. spy) information, as well as the 15.12.1943 issue of the Bulgarian newspaper 'Trakiets'. The following primitive hand-drawn sketch was enclosed to the report, signed by the military attaché, Brig. Gen. Richard G. Tindall, as illustration. Noteworthy is the colour of the marking's centre cross, identified as red.

The change of military marking aroused the interest of foreign states, and not only the neighbours. Traces of this event can be found in American diplomatic papers as well. Occasionally, crude hand sketches illustrate the topic [photos 41A and B].

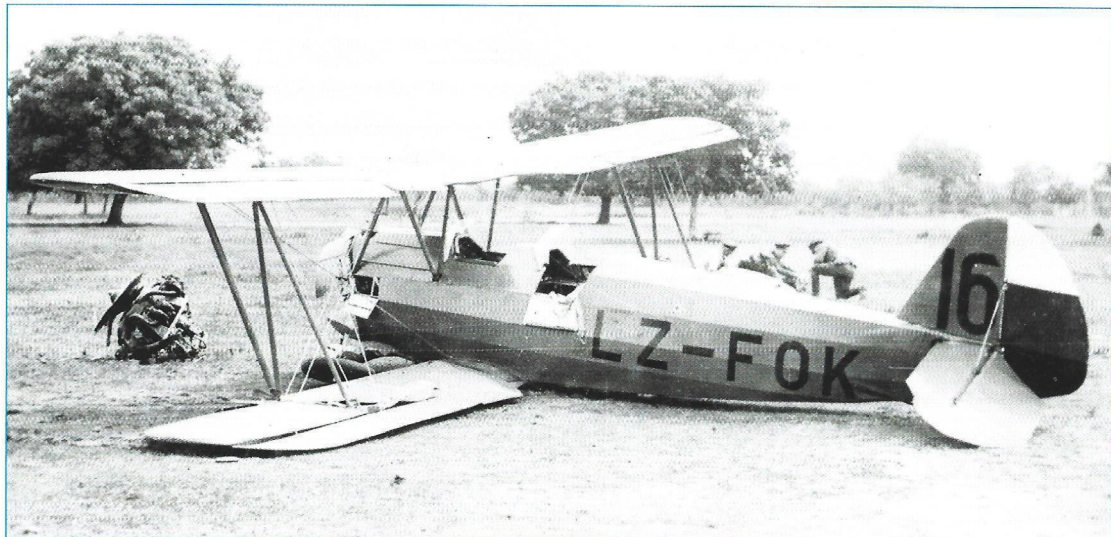
42. Non-combat aircraft types were not applied military markings, they were identified by civilian registrations until the end of their service life. Besides the civilian registration, they wore large size black numbers applied on the fin, as is the case of the depicted Fw 44J Vrabche, LZ-FOK (assigned with NN 10/7021), Werknummer 2297, 'Black 16'. This particular accident happened on the Asen landing ground, west of Kazanlak, on 27 May 1938. Interestingly, this very aircraft was later on photographed wearing 'Black 10' on the rudder! Based on the directive on markings and colours, VNV training should have been painted yellow overall. It's unclear, however, if this directive was valid on imported aircraft as well, which usually wore factory applied paint schemes – until repainted during scheduled overhaul at a specialised workshop in Bulgaria.

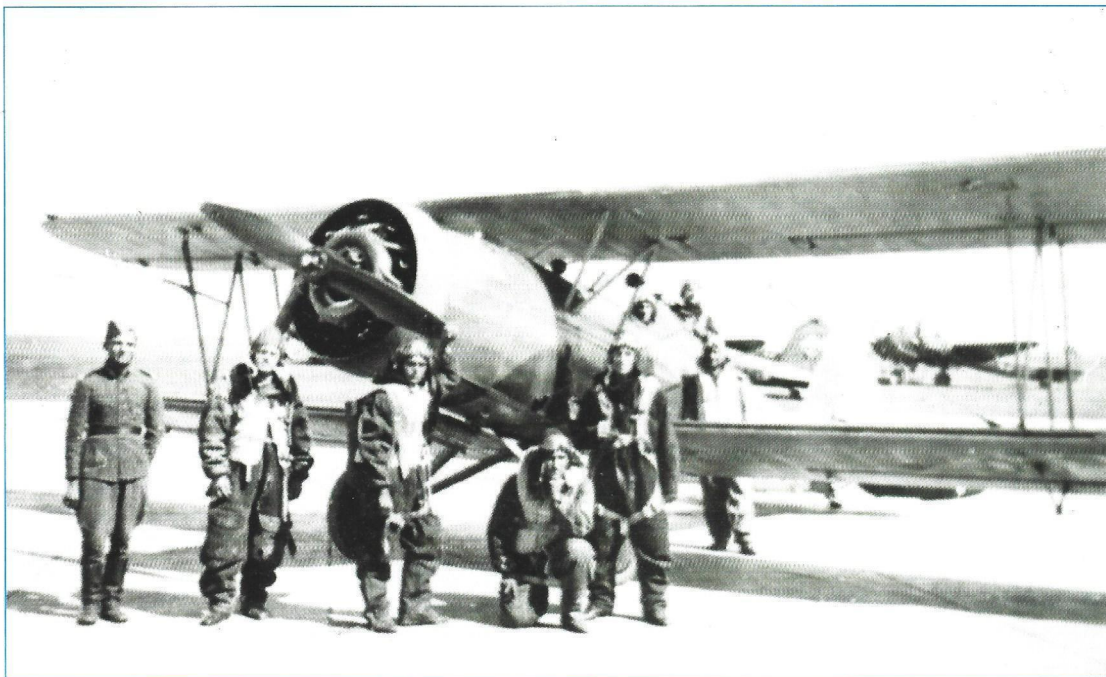
43. A KB-4 reconnaissance biplane, NN 18/7022, stands on the concrete runway of Balchik airfield, close to the shores of the Black Sea, sometime in late April/early May 1941. In the background, a Luftwaffe He 111P and a very rare Ju 88B long-range reconnaissance aircraft can be seen. Ju 88 V24 and V25 – the two Ju 88B prototypes that were used by V.f.H. of 1.(F)/Ob.d.L. for long-range reconnaissance missions over the Soviet Union – entered service on 14 and 30 April 1941, respectively. Notice the 'St. Andrew's Cross' style marking on the wing under surface and the black number 18 on the top of the yellow rudder.

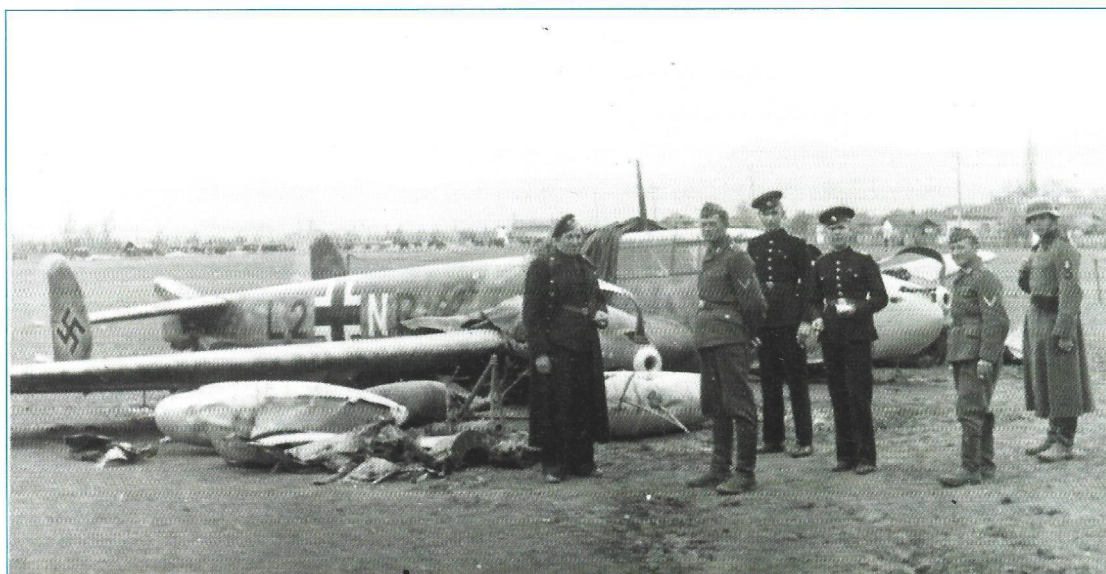
44. Prior to the onslaught on Yugoslavia and 'Operation Marita' of 6 April 1941, Luftwaffe aircraft participating in these operations had their engine cowlings and rudders (often the nose section and the elevators as well) painted yellow, as seen on this bellied Bf 110C of LG 2, L2+NR, used as background for a souvenir shot by Bulgarian and German soldiers in April 1941.

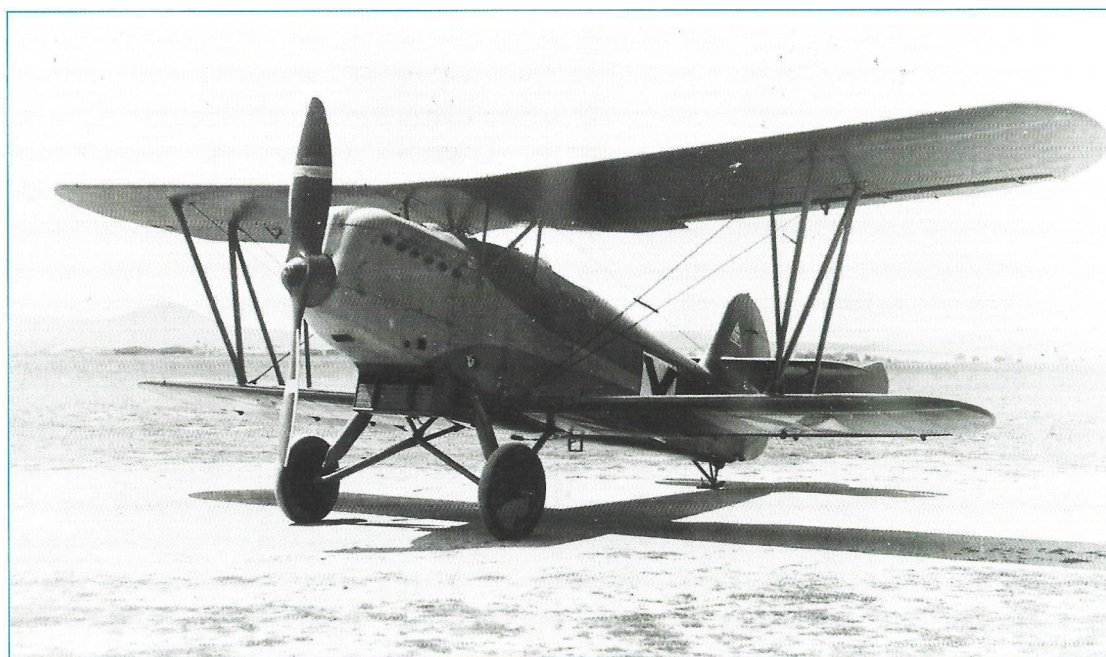
45. From early April 1941 on, most Bulgarian warplanes had their rudders, elevators and the engine cowlings painted in yellow. On certain aircraft types – like the depicted Arado Ar 65F trainer – the red colour engine cowl and rearward tapering fuselage flash was replaced with yellow, to align it with the new 'Axis' colour coding. A few kept their red fuselage flash, and only the engine cowl and rudder were repainted in yellow. However, this was the exception rather than the norm.

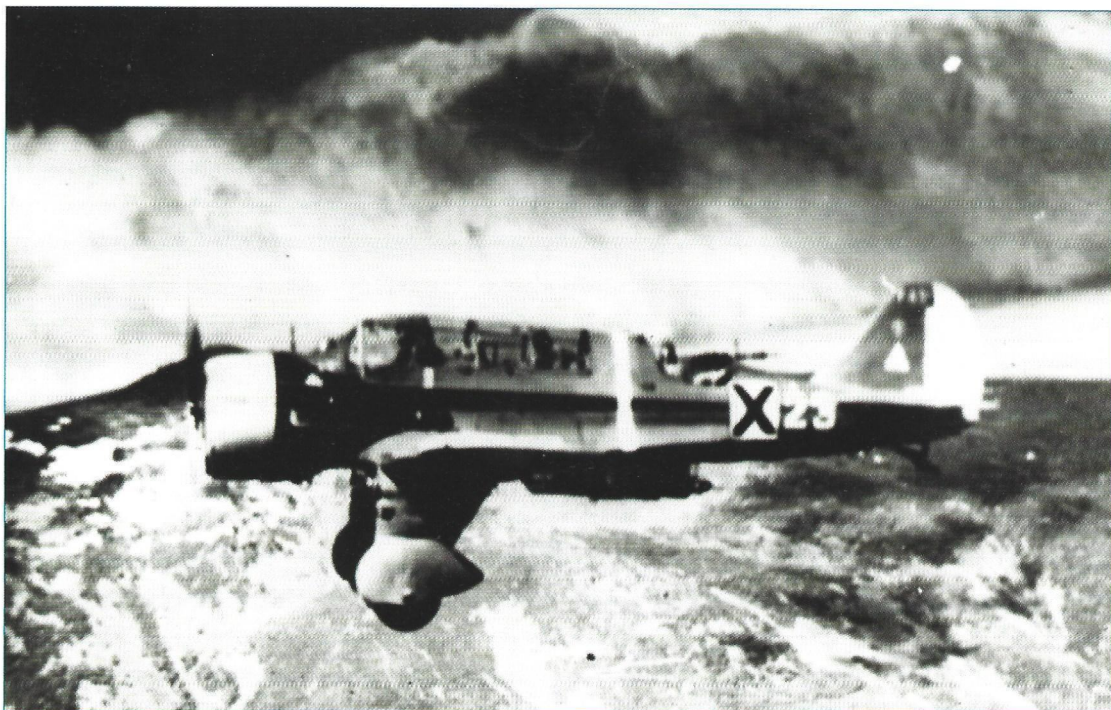
46. Alongside Luftwaffe aircraft operating in the area, Bulgarian warplanes also had their rudders, elevators and the engine cowlings painted yellow from early April 1941 on. A few aircraft types, like the depicted PZL.43A, NN 23/7139, 'White 23', also featured a narrow (about 200 mm wide) yellow ring around the mid-fuselage, as additional recognition feature.

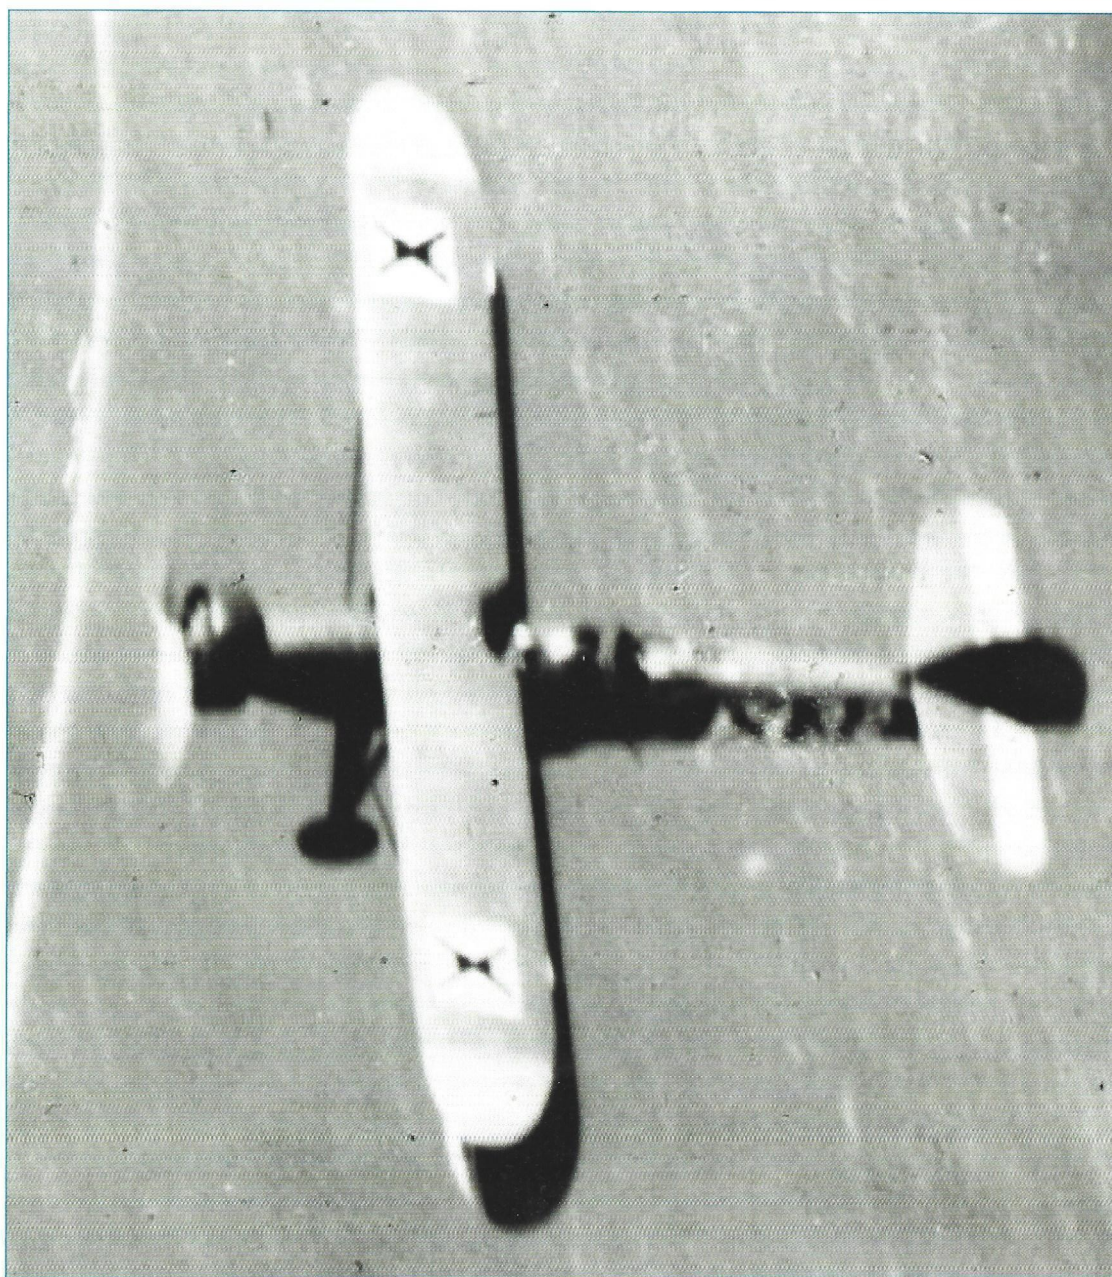
47. This Letov Š-328 reconnaissance biplane, caught by the lenses of the photo camera over the Black Sea, has its upper wingtips painted yellow (besides the bottom ones), along with the elevators – a detail unnoticed yet by published sources.

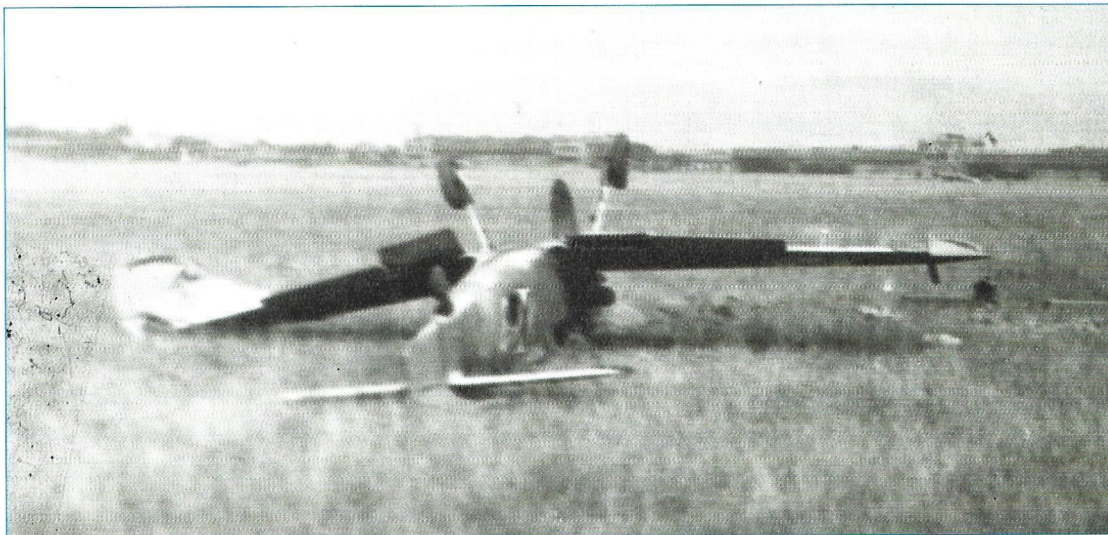
48. Although of indifferent quality, this photo is the only one seen by the Author where a Bulgarian fighter aircraft clearly wears a yellow rear fuselage band, as was the norm with Luftwaffe and other East European Axis aircraft flying on, or in the vicinity of, the Eastern Front. 'White 3', a Bf 109G, turned on its back after a faulty taxiing on soft terrain. Along with the rear fuselage band, this doomed aircraft also has the rudder and lower wingtips in yellow.

Published artworks show, and erroneously labelled black/white photos describe, Bulgarian warplanes – especially the Messerschmitt Bf 109G and Dewoitine D.520 fighters, but occasionally also the Ju 87D Stuka dive-bomber, or the KB-11 'Fazan' army co-operation aircraft – as wearing a wide yellow rear (or mid-) fuselage band as per Axis standards, as seen on all *Luftwaffe* and other Eastern European aircraft. This – with a very few exceptions – was *not* the case for Bulgaria, however. Modellers, authors and artists tend to confuse the post-September 1944 white pro-Allies identifications (rear fuselage band included) with the yellow pro-Axis marking – this is the source of the error. As hinted in the caveat, there were a few exceptions to this display of yellow rear fuselage marking. The author found only one such case displayed on VNVV fighter aircraft, namely a Bf 109G, where the rear fuselage band was undoubtedly yellow. The relevant photo depicts 'White 3' turned on its back after a taxiing accident on soft terrain. This doomed aircraft also has the rudder, lower wingtips and rear fuselage band in yellow. [photo 48]
